FZM-2690 4 November 1963

# STRESS CORROSION CRACKING IN HIGH STRENGTH FERROUS ALLOYS

GENERAL DYNAMICS/FORT WORTH
A DIVISION OF GENERAL DYNAMICS CORPORATION
Fort Worth, Texas

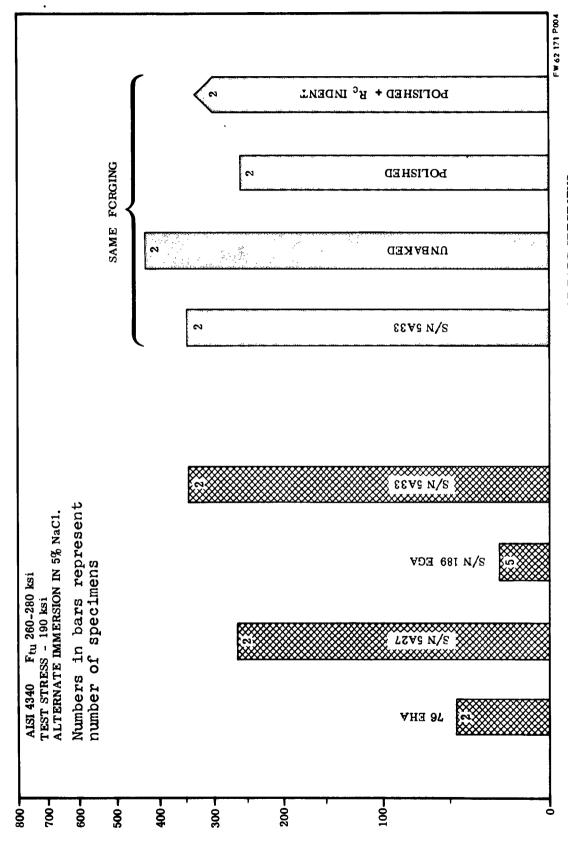
One of the most startling revelations of the tests was the disparity between the test life of the specimens taken from the four forged parts. Figure 4 shows that two of the forgings had lives exceeding 250 hours, while two others survived less than

Figure 4. AVERAGE STRESS CORROSION LIFE OF FORGE PART SPECIMENS. POINTED BAR INDICATES STOPPED TEST.

50 hours. Although the specimens were cut from the forgings in a longitudinal direction, a few specimens were machined from the parting plane of the forging which resulted in a grain flow that was almost transverse. Certain areas exhibited segregation which is believed to have contributed to stress corrosion crack—ing, particularly as the grain direction approached the transverse. An example of the segregation observed may be seen in Figure 5.

Specimens from the forged parts were also used to determine the effects of polishing, surface nicks, and no pretest baking. Referring again to Figure 4, it may be seen that polishing the test section with levigated alumina to produce a metallographic finish, did not improve the resistance to stress corrosion cracking. Putting a Rockwell C indentation in two of these highly polished specimens failed to shorten their lives. Neglecting to bake the specimens appeared to improve the resistance. However, because these specimens were all from the same part and its susceptibility to stress corrosion cracking was above average, the finishes apparently reflect normal scatter.

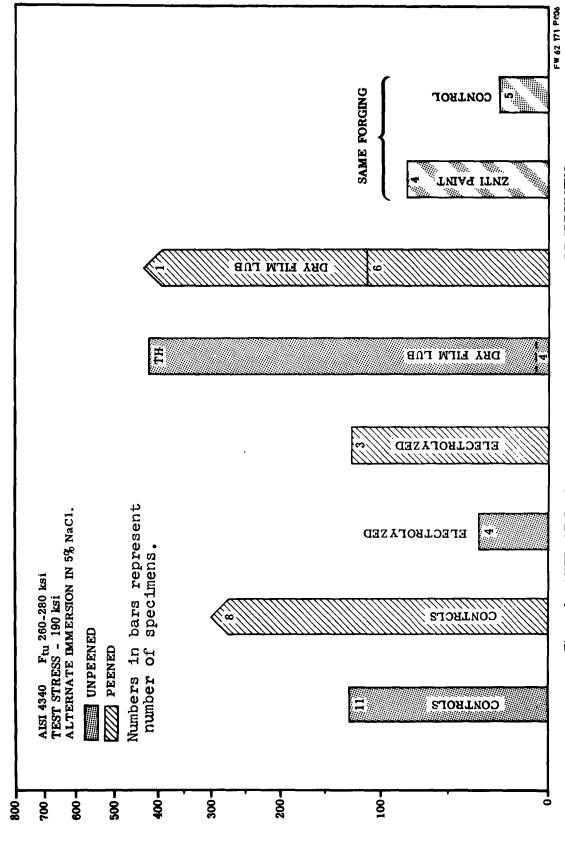
Shot peening forged part specimens effectively doubled their life. Figure 6 shows the average life of the unpeened specimens compared with eight which were peened. Seven of these had not failed after 200 hours and one was still running after 546 hours.

Considered as a group, the forged part specimen results revealed the irregular susceptibility of the material to stress corrosion cracking. Shot peening provided a more significant protection than any of the other three coatings, as shown by the individual test results in Table 3.

Figure 6. AVERAGE STRESS CORROSION LIFE OF FORGED PART SPECIMENS.

POINTED BARS INDICATE STOPPED TEST.

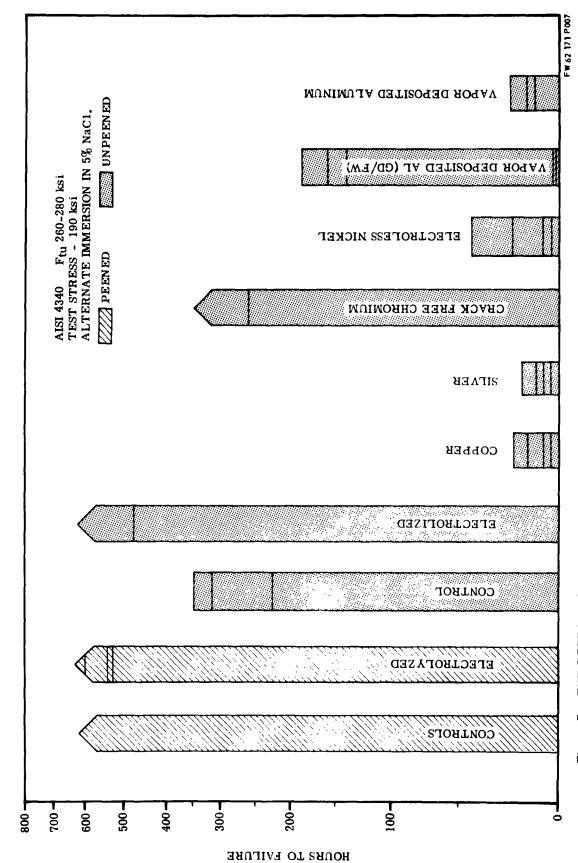
It is immediately apparent, from Figure 7, that the bare rod stock specimens have almost three times the life of the forged part specimens. This might be expected from the more homogenous fine grained structure with a known longitudinal grain direction. A typical stress corrosion fracture, shown by Figure 8, consists of an initial intergranular attack followed by the cup-cone rupture of a ductile tensile failure.

Striking too, is the short survival of the copper, silver, and electroless nickel plated specimens. These metals are cathodic to the steel and accelerated the corrosive attack. For example, small fissures in the electroless nickel coating led to the pitting attack illustrated by Figure 9. As stresses build up at these concentrating points, intergranular cracking develops until failure occurs. The crack-free chromium plate offered good protection, although it eventually succumbed to the corrosive media and began to spall.

Looking again at Figure 7, the Electrolized coating afforded the best protection and was the only one of the group to have life longer than the control specimens. Electrolizing seemed to shorten the life of the shot peened specimens slightly. Two sources of vapor deposited aluminum were also tested. This laboratory's

THE EFFECT OF VARIOUS PLATES ON THE STRESS CORROSION LIFE OF ROD STOCK SPECIMENS. POINTED BARS INDICATE STOPPED TEST. HORIZONTAL LINES INDICATE FAILURES Figure 7.

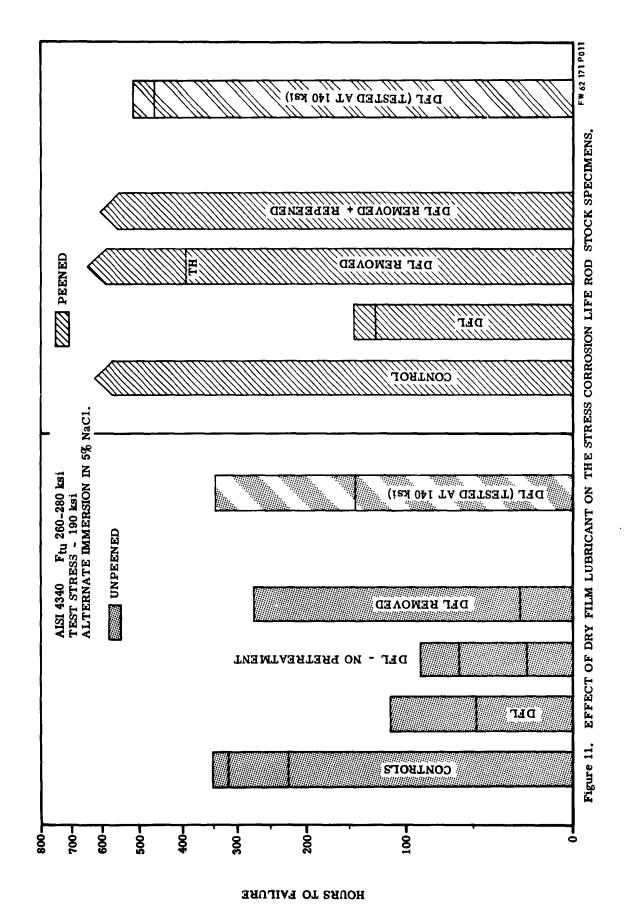
The application of a dry film lubricant reduced the resistance to stress corrosion cracking of both the unpeened and peened specimens (Figure 11). The suspected cause of this loss of resistance was the phosphate pretreatment which severely pitted the steel. The extent of the pitting is shown by Figure 12. However, when the pretreatment was not applied the stress corrosion cracking was more rapid, and if the dry film lubricant was removed by vapor honing the resistance to cracking was nearly restored to the level of the control specimen. Both the peened and unpeened specimens responded in a similar manner.

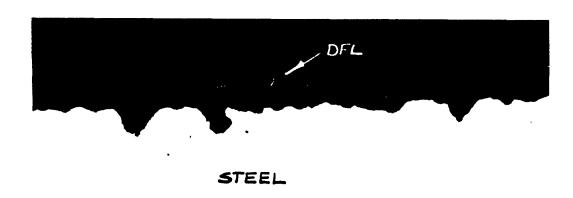
Figure 12 - PITTING OF THE STEEL BY THE PHOSPHATE PRETREATMENT FOR THE DRY FILM LUBRICANT (DFL). 250X

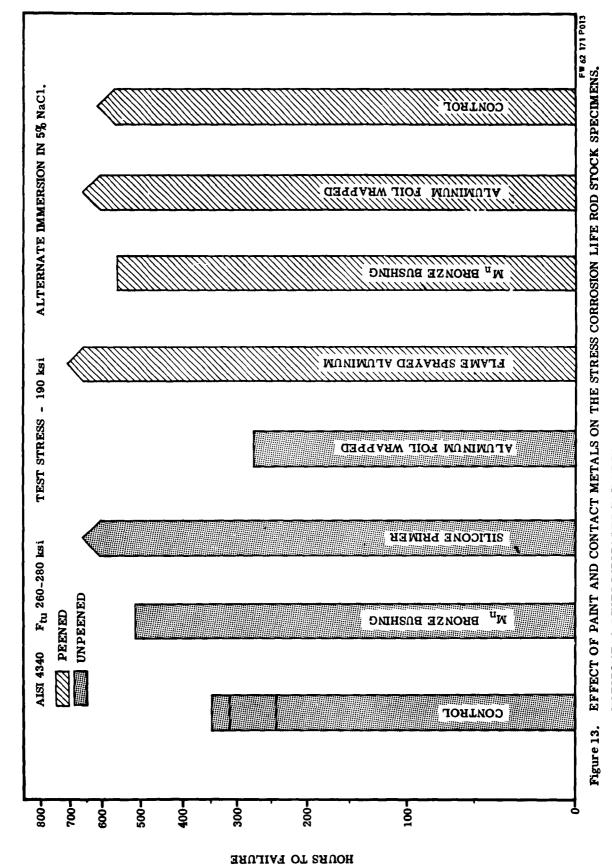
HORIZONTAL LINES INDICATES FAILURES.
POINTED BARS INDICATE STOPPED TEST.

shown in Figure 15. Results of the stress corrosion test were good; the minimum specimen life was about 250 hours. One specimen survived over 800 hours before the test was stopped. By comparison, Figure 16, the electroless nickel coating stimulated the susceptibility to stress corrosion cracking.
